# **XRF Lead-Based Paint Inspection & Risk Assessment Report**

Report Date: January 26, 2023

**Conducted At:**  
66 Atoah Road  
Robbinsville, NC 28771

Matrix Job # 230162

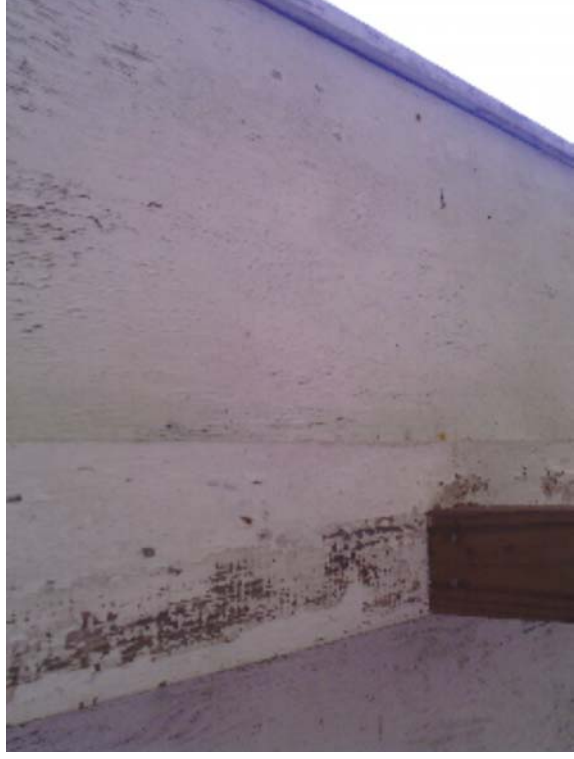
Reading #12

12	Positive	Off	Soffit	Wood	A	Deteriorated	White	First	Exterior	3.8 mg/cm <sup>2</sup>	Action Level
13	Positive	Off	Facia	Wood	A	Deteriorated	White	First	Exterior	2.7 mg/cm <sup>2</sup>	Action Level
14	Positive	Off	Window Casing	Wood	A	Deteriorated	White	First	Exterior	2.7 mg/cm <sup>2</sup>	Action Level
15	Negative	Off	Deck Trim	Wood	A	Deteriorated	Blue	First	Exterior	0.0 mg/cm <sup>2</sup>	Action Level
16	Negative	Off	Wall	Aluminum	B	Intact	White	First	Exterior	0.0 mg/cm <sup>2</sup>	Action Level
17	Positive	Off	Window Casing	Wood	B	Deteriorated	White	First	Exterior	1.3 mg/cm <sup>2</sup>	Action Level
18	Negative	Off	Gutter	Aluminum	B	Deteriorated	White	First	Exterior	0.1 mg/cm <sup>2</sup>	Action Level
